August 9, 2017

**Subject:        Lover's Oak Arborist Assessment  
                 Success Avenue and Lake Morton Drive  
                 Lakeland, Polk County, Florida  
                 E Sciences Project Number 3-0002-001**

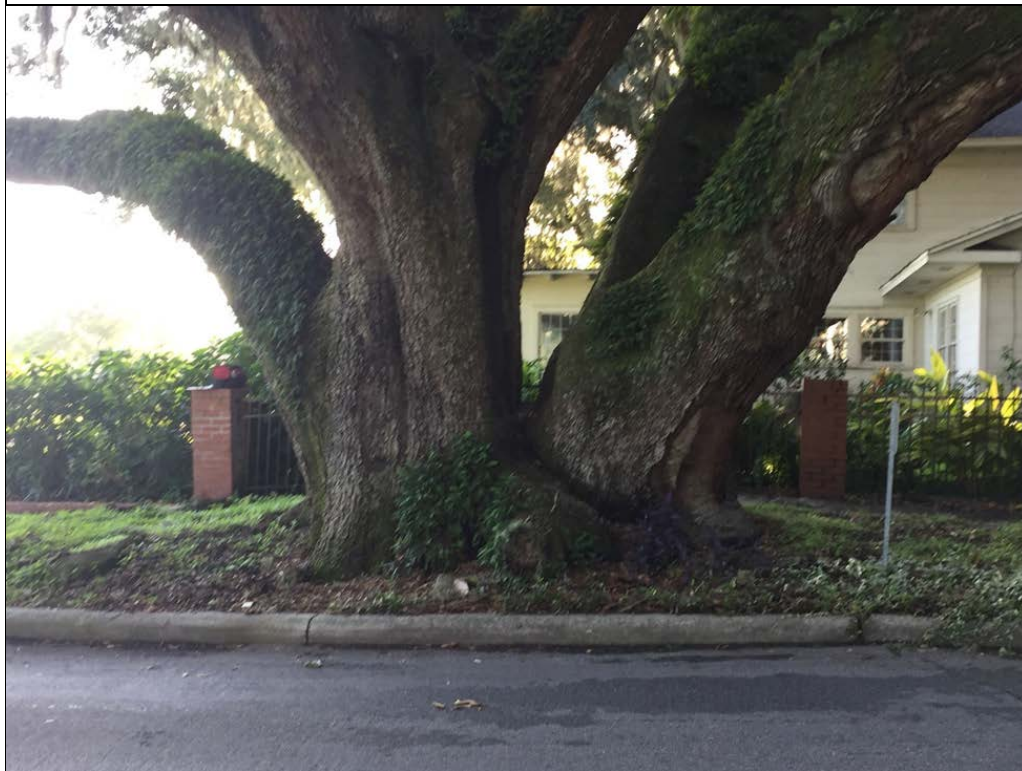
During our assessment, it appeared that the tree was healthy with some areas of dieback and low crown density, however, the tree has structural defects which cannot be corrected. The trunk forms a basal codominant with included bark. This condition occurs when one or more trunks emanate from grade and contact one another. This union was inspected with the use of a probe and it was determined that there is no connective tissue between the two trunks. The original connective tissue has decayed due to the contact pressure from annual secondary growth in the trunks. The

decay and strength loss increases each growing season until failure occurs when the load bearing capacity is exceeded.

The two leaning trunks of the tree are unable to develop response growth in the crotch area. In addition, the tree has decay in the crotch and no connective tissue. This tree has a large canopy which compounds the likelihood of failure of an included, basal codominant trunk due to excessive weight over the defective crotch. This tree's broad spreading canopy creates a strong pull in an outward and downward fashion over the weakened crotch. This condition is exacerbated during wind events and rainy periods when a tree's weight can increase substantially. The decay associated with this defect is progressive and will continue to worsen with each passing year.

Photo 1  
Basal codominant with included bark

The tree has average-good health but should not be preserved because of the structural defect of the included, basal codominant. The decay in the south trunk will exacerbate the decay associated with the inclusion. There is no viable options to mitigate the included, basal codominant. Bracing with rods would not likely be successful over time due to the additional decay in the more external areas of the south trunk. There is likely not enough sound wood to hold the nuts and washers in the location where the rods would need to be installed. As there are targets of people and/or property in this area, and we have identified no viable mitigation options to correct the structural defect, the tree is recommended for removal.

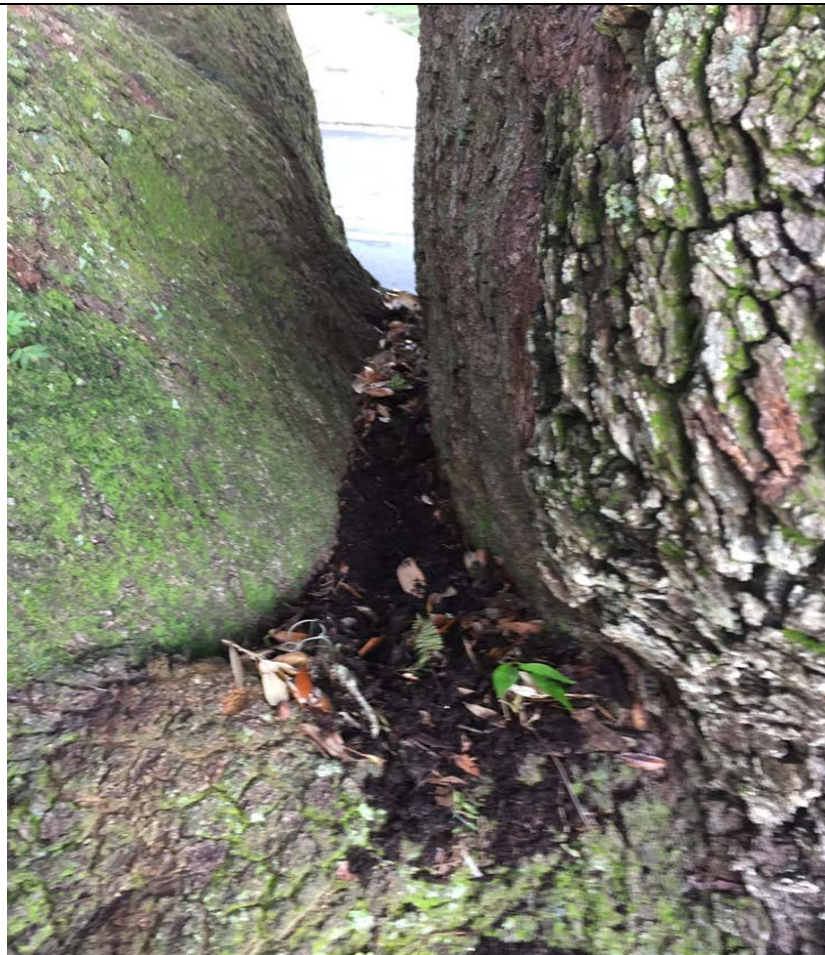
Photo 2  
Union inspected with the use of a probe

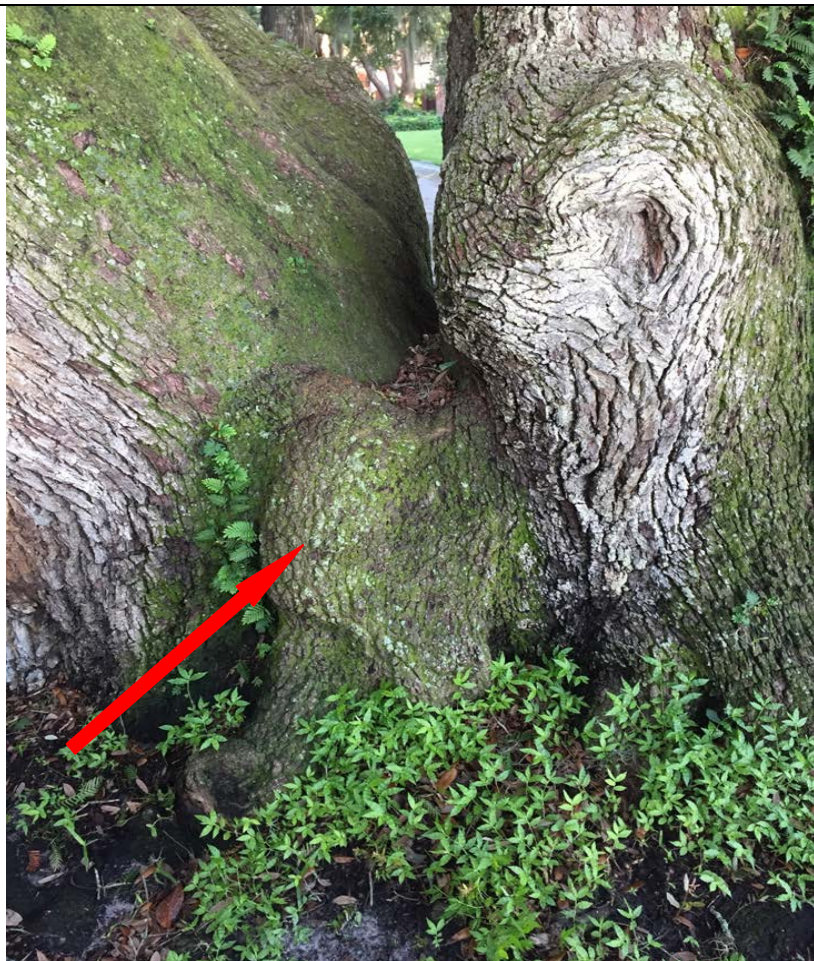
There is an inclusion bulge indicating internal decay on the east side of the basal codominant. Once the codominant trunks have reached a point where inward growth is no longer possible new tissue often forms creating a pronounced bulge spanning the base of the two trunks. This bulge forms at a point below the two codominant stems where the new wound wood has grown in response to the continual internal fracture and included bark underneath.

Photo 3  
Inclusion bulge on east side

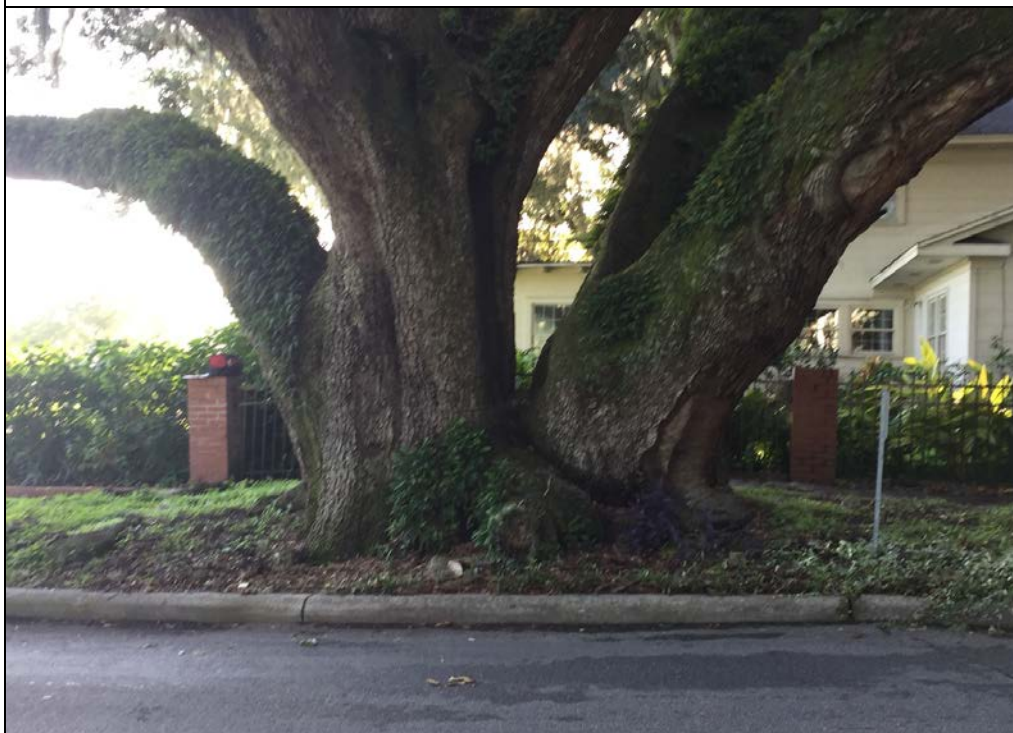
There are important factors that create a predisposition for failure. The aspect ratio is approximately 1:1, meaning both trunks are essentially the same size in diameter. As the aspect ratio decreases the strength of the trunks increases; therefore, the strength in the subject trunk is compromised. A 1:1 ratio has the highest probability for failure as the two leaning trunks of the tree are unable to develop response growth in the crotch area.

Photo 4  
1:1 Aspect ratio

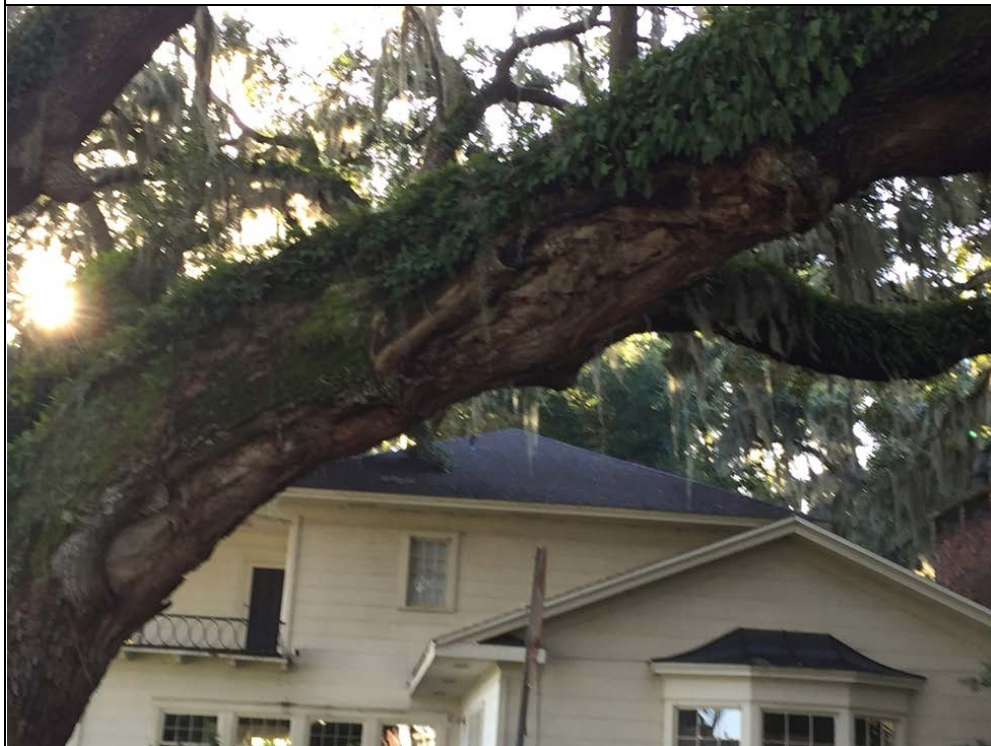
The 38-inch diameter trunk to the south has a significant amount of decay potentially from contact from large vehicles. Consequently, the extending branches have extensive dieback. This decay is present along the southern most trunk and continues down into the main trunk. Directly below this decay is a wound in the main trunk. It is our opinion that the decay in the overhead branch and the main trunk have likely connected internally causing a high predisposition for failure. This defect cannot be corrected with pruning which would leave a 38-inch wound on the south side of the tree. In addition, if this trunk was removed there would be no counter weight leaving most of the weight on the east side over the sidewalk and private residence.

Photo 5  
38" Diameter trunk to the south with decay

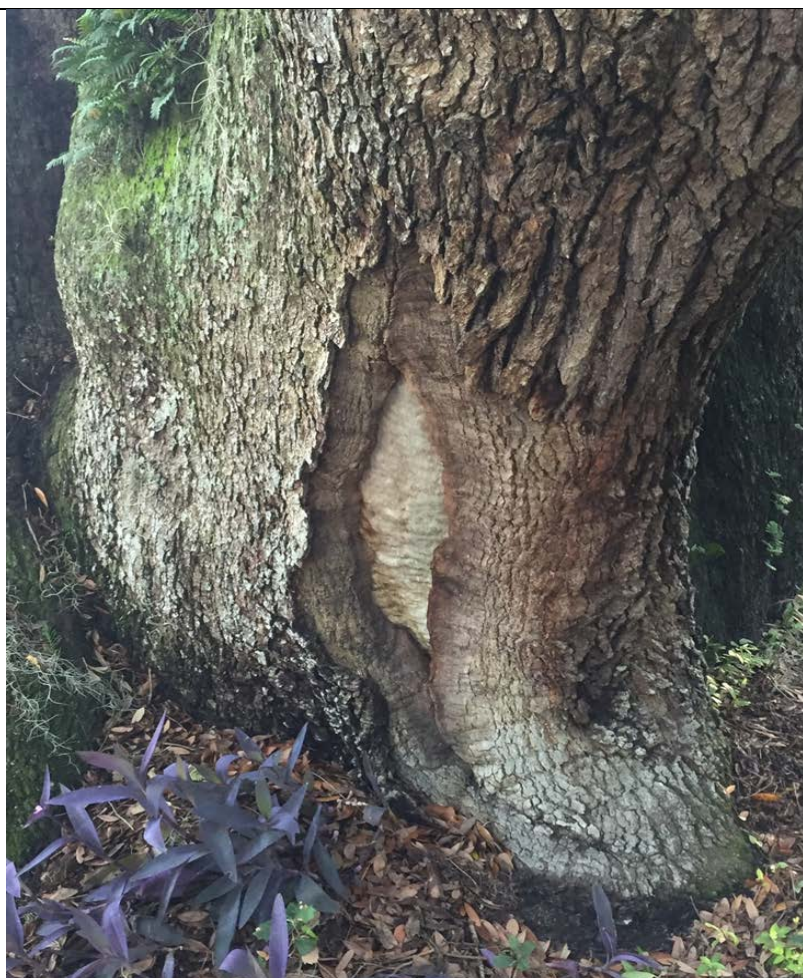
Photo 6  
Wound in main trunk below decay along  
southern trunk

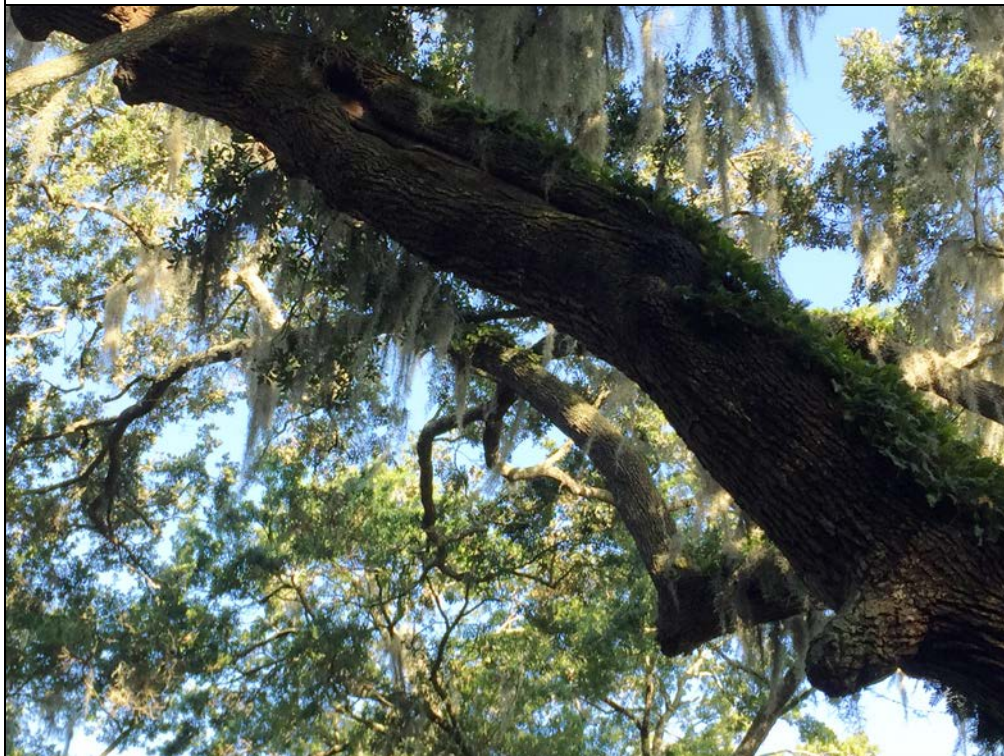
There is also evidence of other areas of decay in the canopy of the tree. Our observations indicate that this decay was likely caused by a lightning strike that entered the canopy with a resultant exit

Photo 7  
Other area of decay in canopy of tree

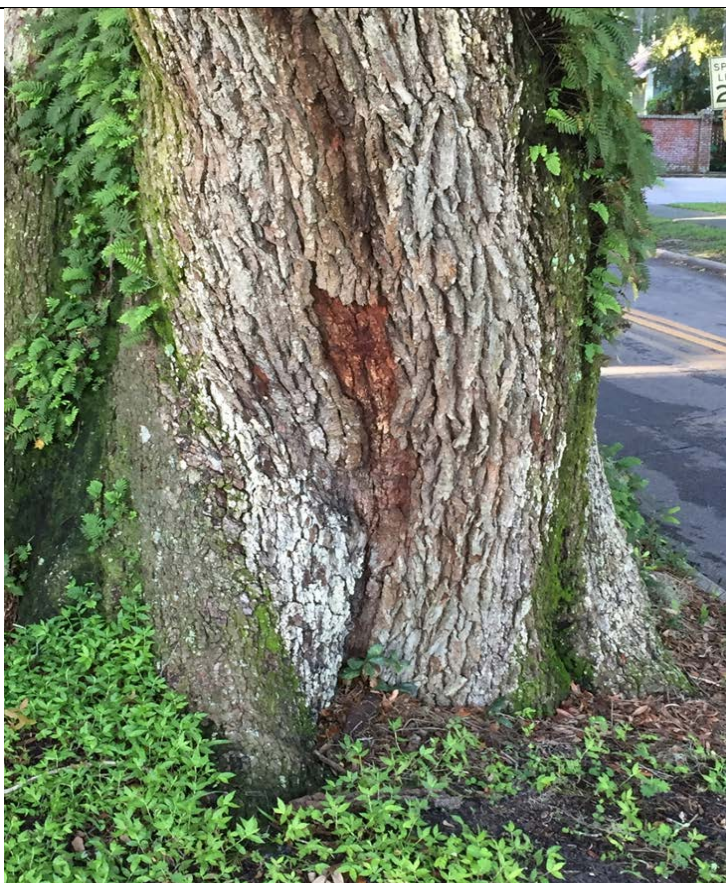
wound on the north side of the trunk near grade. The city has effectively pruned the tree to mitigate defects by pruning back branches gradually. The tree has reached a point where additional pruning of defects may negatively affect the tree due to a deficit of stored up energy to overcome the pruning.

Photo 8  
Exit wound on north side near grade

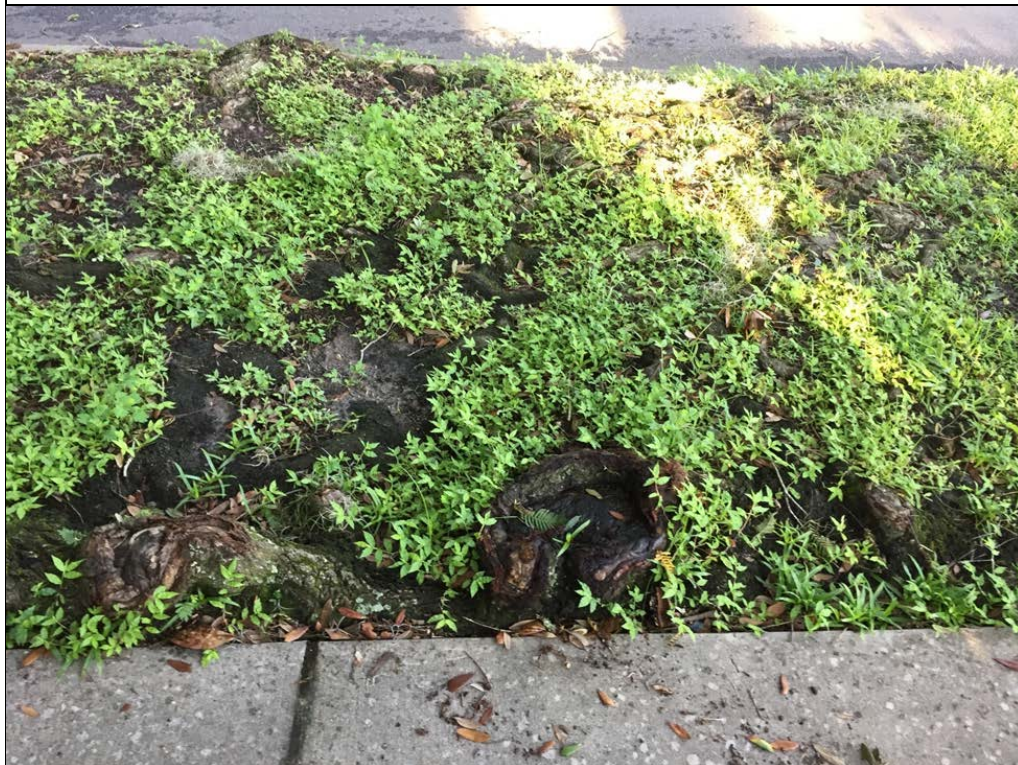
The tree has outgrown the space provided between the sidewalk and the street. The roots are girdling in the provided space leaving the tree with an abbreviated root system to the east and west. There are wounds present on the surface roots from pruning and other mechanical maintenance equipment such as a mower. These wounds could result in decay in the root system.

Photo 8  
Girdling roots and surface roots  
with wounds present
